| | Information technique Technical information Información técnica | Document n° NT 76-01 |
| Sujet: vérification étoile de sélection 250/300 SE-(R) Subject: verification of 250/300 SE-(R) shift drum locator Asunto: verificación estrella selectora 250/300 SE-(R) | | Date/Fecha 02/06/2014 |

Due to a manufacturing defect by the supplier, it is possible for the steel needles [1] from the shift drum locator ref 3811 to come out [2] and damage the engine. We ask you to complete the following procedure to replace the star. 1:30 hours of labor is allowed and the necessary parts required are also covered.

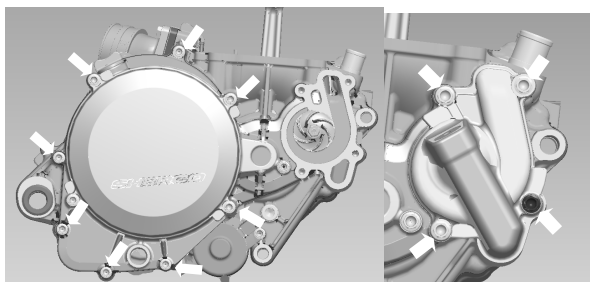
- Dismount the exhaust pipe.
- Servicing the cooling system (see owner's manual)
- Drain the engine oil (see the manual for details)
- Dismount the rear brake pedal.
- Remove the clutch inner cover. To dismount the crankcase on the frame, only unscrew the screw [3] and don't remove it. Remove all the other M6 screws.
- Dismount the clutch inner cover.

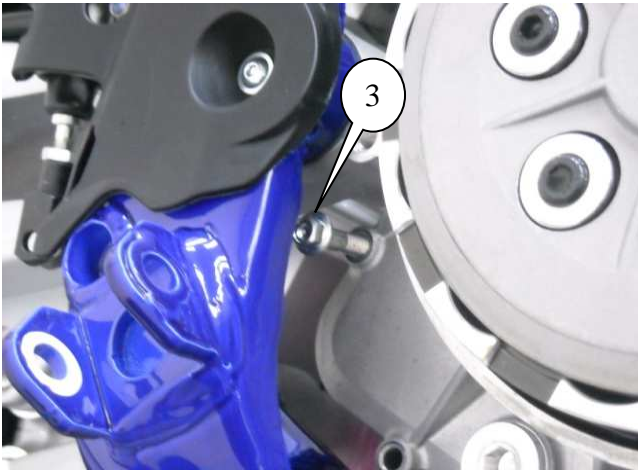
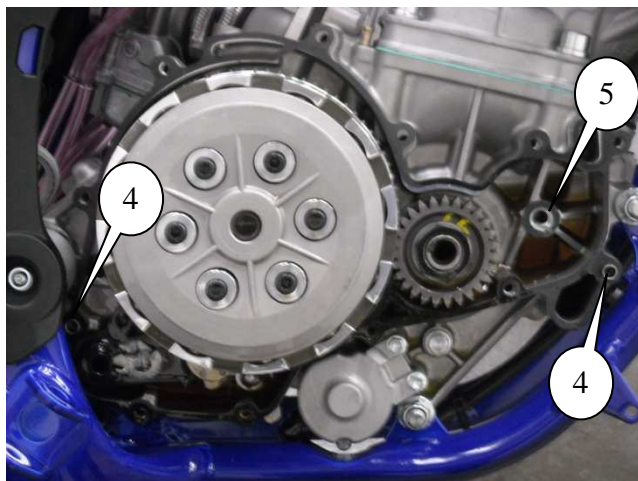
Be careful with the two dowels [4] and water pump washer [5]

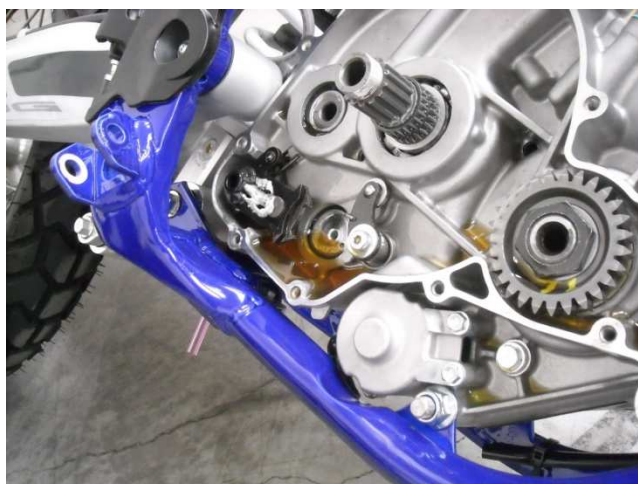
- Remove the pressure clutch plate.
- Remove the clutch hub nut.
- Remove the clutch but washer.
- Remove the clutch hub assembly + discs.
- Remove the shift drum locating screw
- Press locking lever and sliding plate away from the shift drum locating and take off the shift drum locator
- Release the locking lever

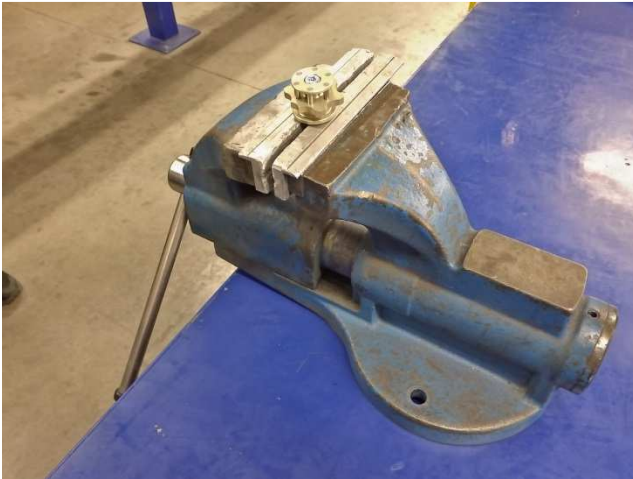
Control the shift drum locating

- Place a CHC M6x35 screw in the shift drum locating and retain in a vise

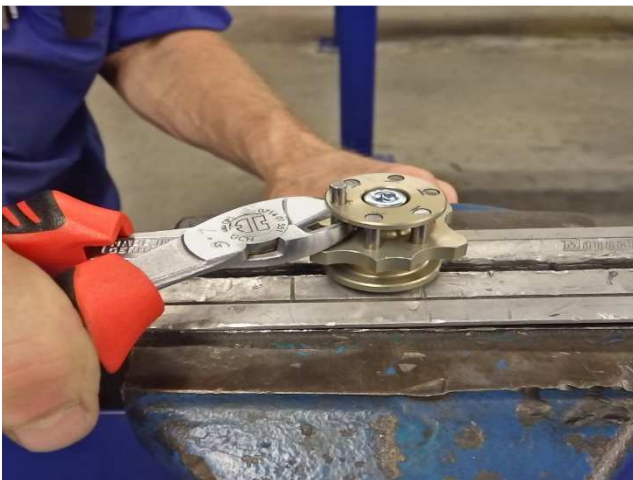
- Using a pair of cutting pliers, pry the needles and make sure that they do not come out.

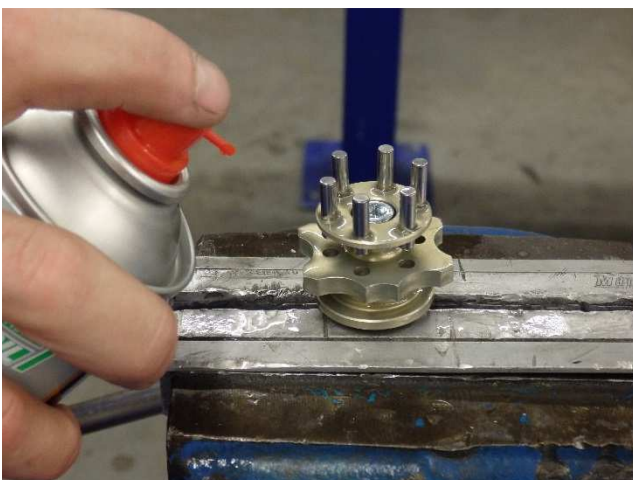
- If the needles are loose and come out, degrease them with a degreaser (Minerva brake cleaner and degreaser)
- Use compressed air and blow the assembly clean and dry

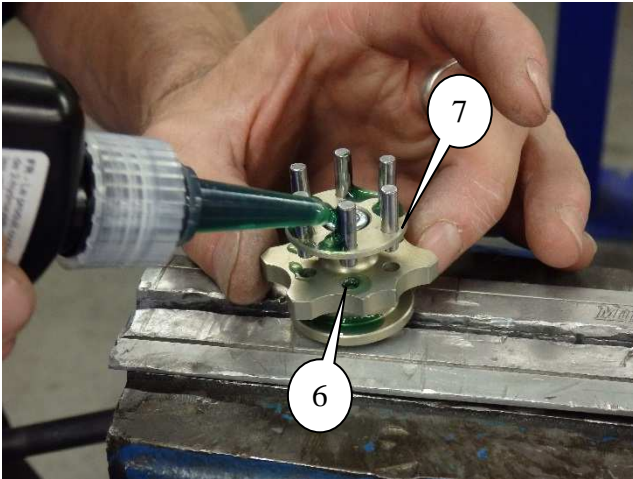
- Apply strong thread locker to the bottom (6) of the base and to the needles (7).

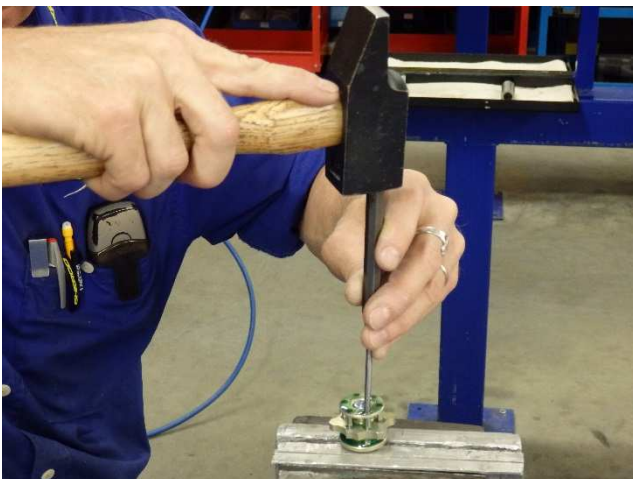
- Insert the needles with a punch. Verify that they do not protrude above the aluminum part
- Clean off any excess threadlocker
- Wait for the product to take effect (minimum 2 hours)
- Check the star to make sure that the needles remain in place.

If in doubt, replace the star under warranty.

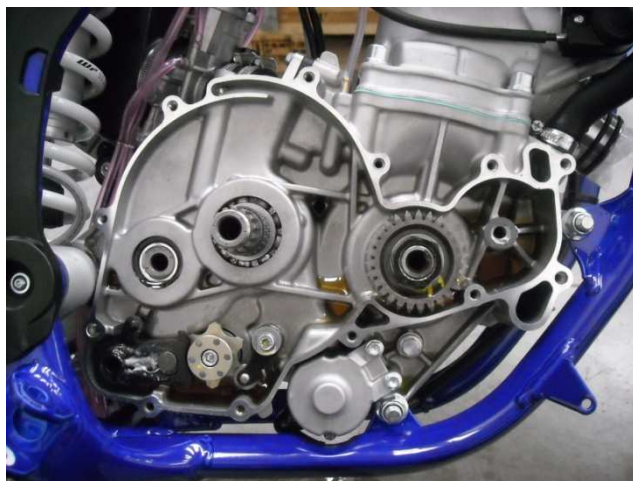
If everything is ok, refit the assembly in reverse order of disassembly, taking care to install a new clutch cover gasket (ref 3831), a new copper washer for the coolant circuit drain plug (ref 2390) and a clutch/ brake washer (ref 4931) .

Be careful with the shift drum locating indexation dowel.
