| | <b>Information technique</b><br><b>Technical information</b><br><b>Información técnica</b> | <b>Document n°</b><br><b>NT 71-01</b> |
| <b>Sujet: vérification tendeur de distribution 250-300 SEF/R 2014</b><br><b>Subject: checking the chain tensioner on the 2014 250-300 SEF/R</b><br><b>Asunto: verificación del tensor de distribución 250-300 SEF/R 2014</b> | | <b>Date/Fecha</b><br><b>28/11/2013</b> |

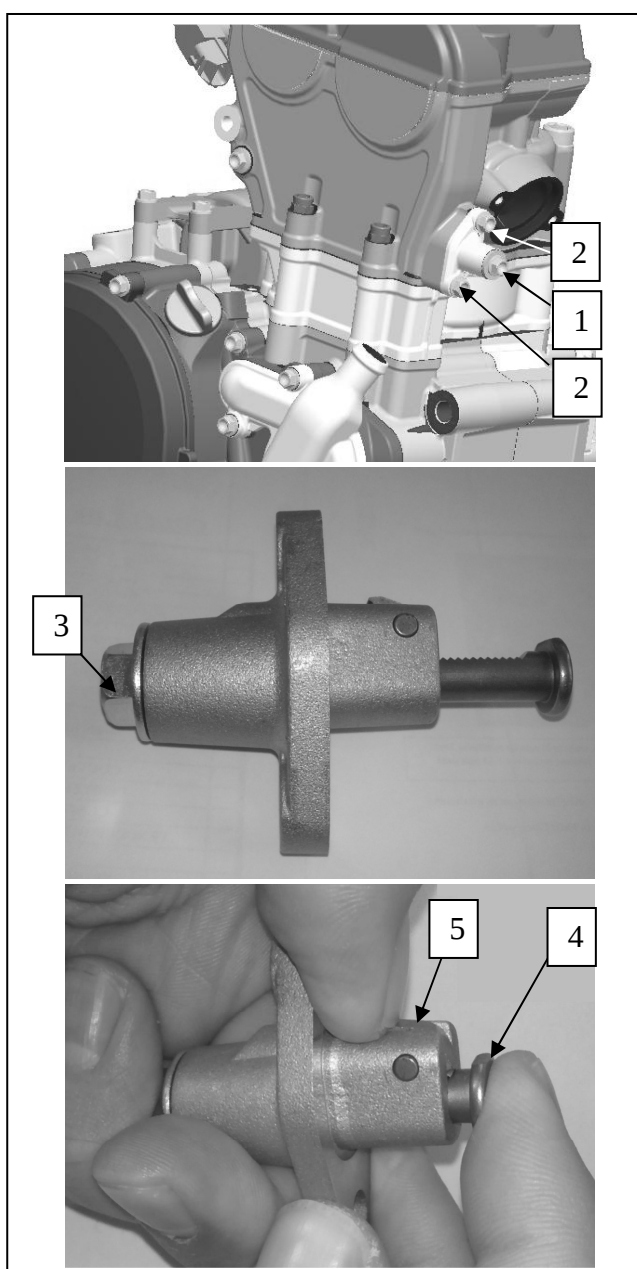
- Rotate the engine so that it is at top dead center (TDC)
- Loosen the central screw of the chain tensioner (1)
- Remove the 2 chain tensioner screws (2)

- Replace the central screw. **Tighten to 10 Nm (3)**
- Press the locking pawl down (5) then push on the pin (4)
- Release the push pin. It must return to the position shown in photo #2 by itself, because of the spring tension.
- If this is not the case, the tensioner must be replaced with a new one.
- Reinstall the chain tensioner using a new gasket ref 0922. **Tighten to 10 Nm.**
